Re: NAPL Delineation Pilot Study
 SRSNE Site -- Southington, Connecticut
 Bruce Thompson, *de maximis, inc.*
 Bernard Kueper, Queens University
 Gary Cameron, BBL

This document describes the results of a pilot study of field methods used to visually identify non-aqueous phase liquids (NAPLs) in soil at the Solvents Recovery Service of New England (SRSNE) Site (the Site) in Southington, Connecticut. The pilot study was performed as described in a letter from Blasland, Bouck & Lee, Inc. (BBL) to the United States Environmental Protection Agency (USEPA) dated October 24, 2003. BBL prepared this letter on behalf of the Potentially Responsible Parties (PRP Group or "the Group") for submittal to the USEPA and the Connecticut Department of Environmental Protection (CT DEP). This document presents the following information:

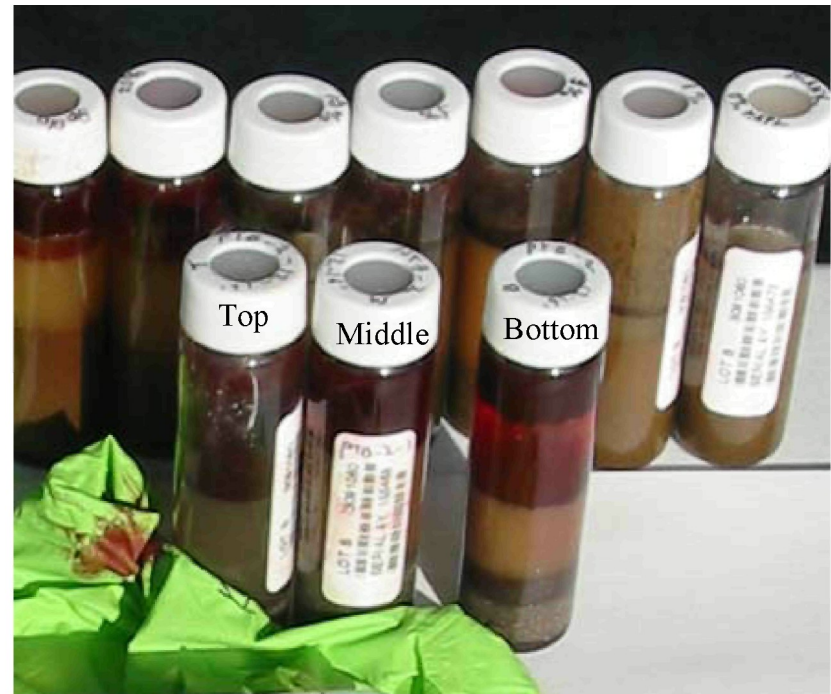
PTB-2 (12-16 feet bgs)

- Evaluation for visible NAPL sheen or dark brown NAPL in soil – NAPL sheens generally were not observed in soil samples. NAPL was observed within the unopened Lexan™ sleeve in some circumstances. For example, NAPL was observed as a separate phase liquid above the soil within the Lexan™ sleeve for the 12-15 ft depth interval at boring PTB-39 (Attachment 2). In addition, NAPL droplets were observed inside the unopened Lexan™ sleeve in soil in a few soil samples (e.g., the 12-16 ft interval at PTB-2 and 8-12 ft depth interval at boring PTB-36). After opening, NAPL staining or NAPL droplets were observed within the soil sample after splitting the sample axially (e.g., the 8-12 ft interval at boring PTB-23 and the 10-12 ft interval at boring PTB-26).

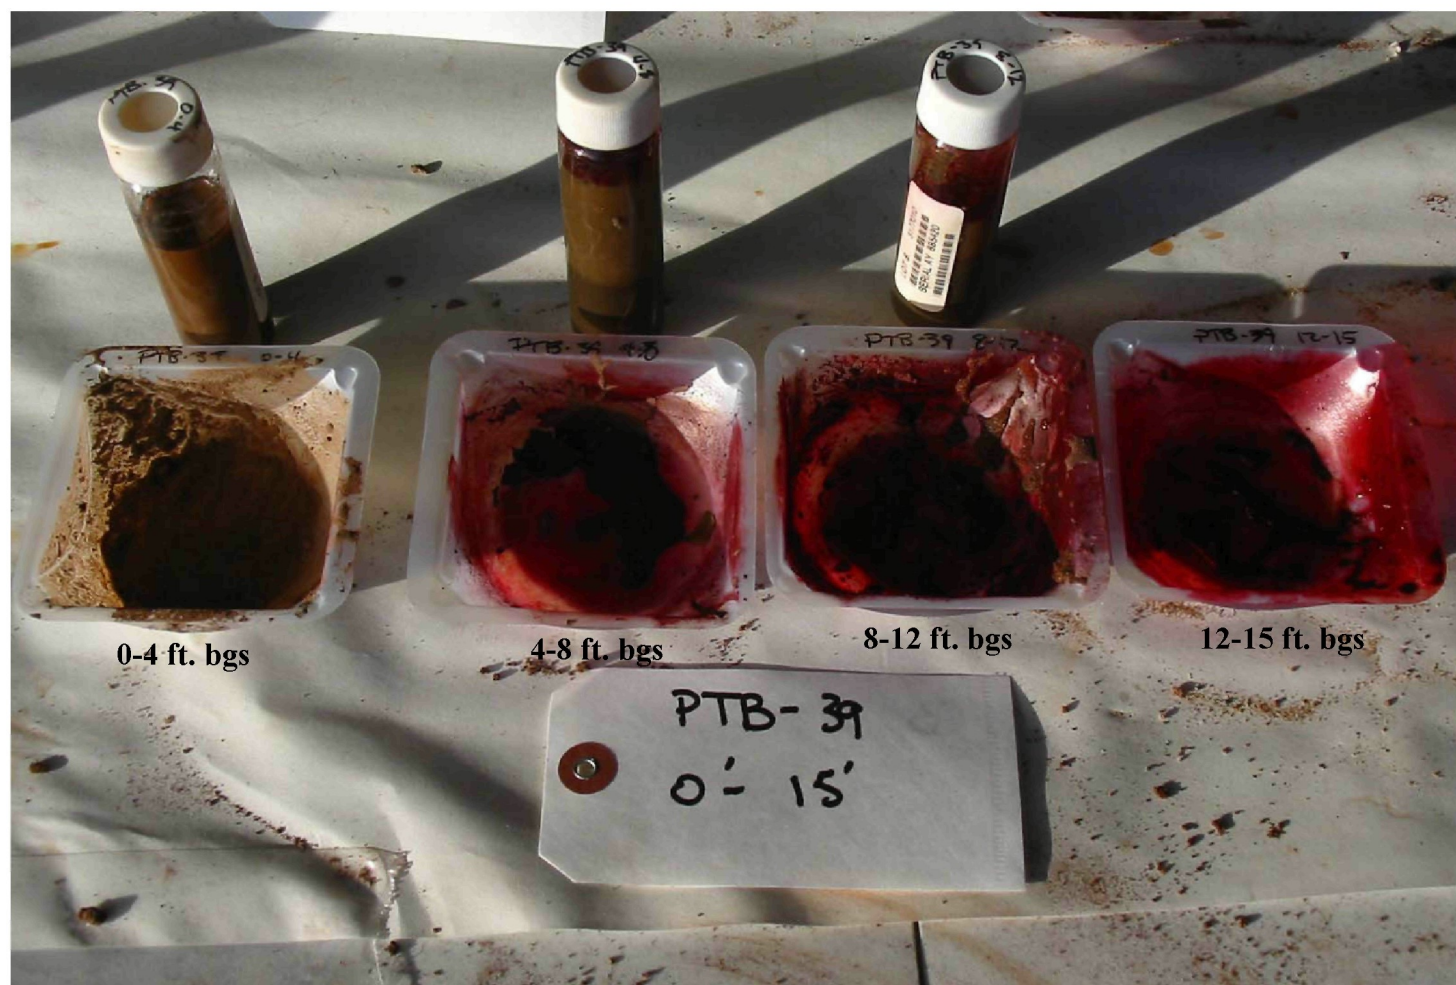
PTB-39 (0-15 feet bgs)

Location ID	Date	Refusal Depth (ft. bgs)	Depth Interval (feet below ground surface)		Observation/Test Results ¹						Participants Involved in Interpreting NAPL Presence ²										Miscellaneous Comments/Observations
											Mangion		Healey		Kueper		BBL Geologist		de maximis		
			Top	Bottom	PID (ppm, maximum)	Visible NAPL Sheen	Visible NAPL	Soil-Dye Smear Test	Soil-Water Shake Test	Oil Red-O Shake Test	Residual	Pooled	Residual	Pooled	Residual	Pooled	Residual	Pooled	Residual	Pooled	
PTB-39	11/7/03	15	4	8	450	+	-	+	foam and sheen	+	0	0	+	-	0	0	+	-	0	0	Strong residual 10-15% range.
PTB-39	11/7/03	15	8	12	2,000	+	+	+	foam and sheen	+	0	0		+	0	0		+	0	0	Very strong hit ≥ 30% standard.
PTB-39	11/7/03	15	12	15	3,500	+	+	+	foam and sheen	+	0	0		+	0	0		+		+	1/8" NAPL pooled with water above core.
